Manhole Inspection Summary

Manhole # **S29G__065MH**

Location Address: **W Redwood**

Cross Street: **S Arch St**

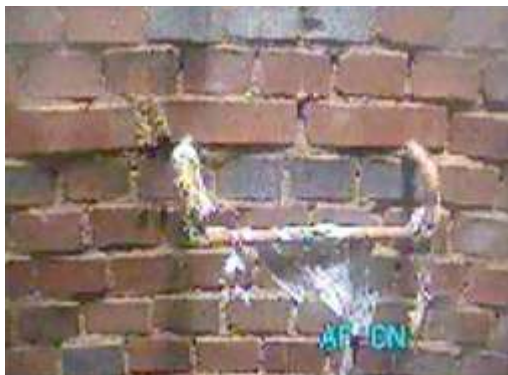
Defect 3

Surcharge ☒ **Evidence Of Surcharge** Depth: **4** (ft.) ☐ Active Surcharge Present

48 inches surcharge evidence

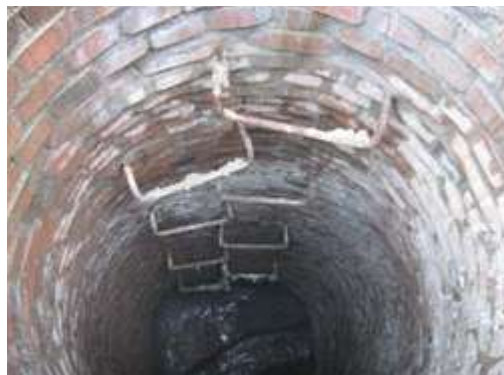
Defect 2

Steps Count: **8** Missing: **0** ☒ **Corroded**

oxidized rungs

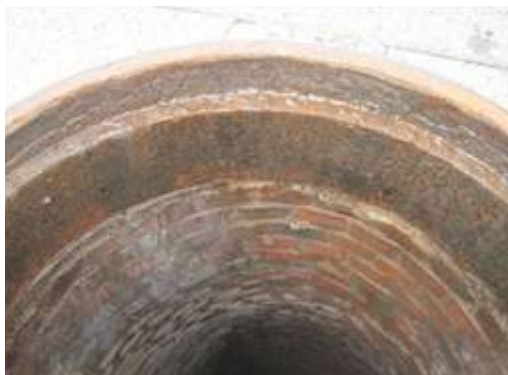
Defect 1

Frame Offset: **0** (in.) Condition: ☐ Sound ☐ Cracked ☒ **Leaks**

lid/frame infiltration

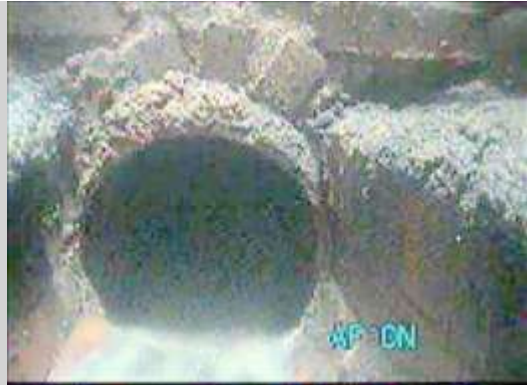
12 O'Clock Outflow

12 in. Circular Gravity Sewer
Pipe Out @ 12 O'Clock

Pipe Height: **12** (in.) Rod and Bar (Angled)
Pipe Material: **Clay** ☐ Pipe Lined
Invert Depth: **15.40** (ft.) Flow Characteristics: **Fast**
Deposits: ☒ None ☐ Mud ☐ Sludge ☐ Debris ☐ Grease
Silt Depth: **0** (in.) Deposits Extent:
Infiltration: **None** Pipe Seal Cond: **Sound**

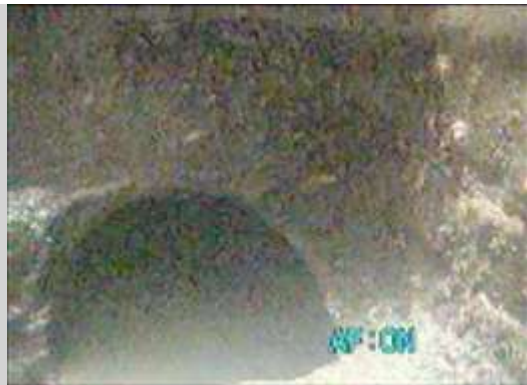
5 O'Clock Inflow

12 in. Circular Gravity Sewer
Pipe In @ 5 O'Clock

Pipe Height: **12** (in.) Rod and Bar (Angled)
Pipe Material: **Clay** ☐ Pipe Lined
Invert Depth: **15.24** (ft.) Flow Characteristics: **Fast**
Deposits: ☒ None ☐ Mud ☐ Sludge ☐ Debris ☐ Grease
Silt Depth: **0** (in.) Deposits Extent:
Infiltration: **None** Pipe Seal Cond: **Sound**
